Manhole Inspection Summary

Manhole # S19C1_013MH

Insp Date: **5/29/08 1:05 PM**

Location Address: **1964 sponson st**

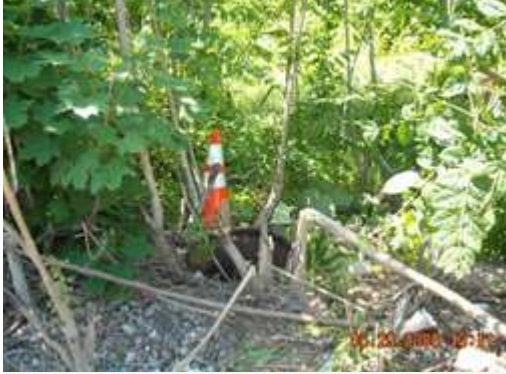
Location View

Comments **Railroad easment behind guard rail, in the overgrowth**

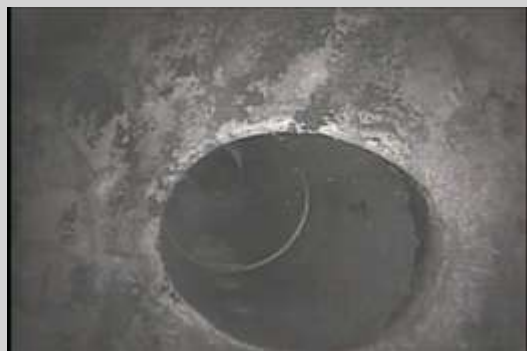
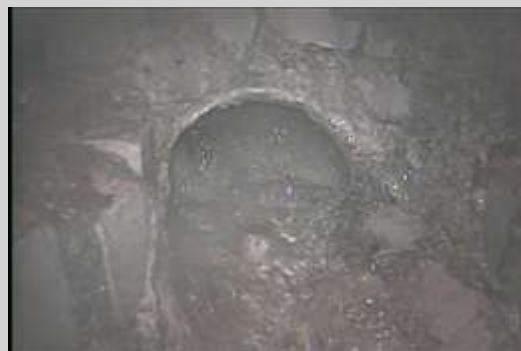
7 O'Clock Inflow

8 in. Circular Gravity Sewer

Pipe In @ 7 O'Clock

Drop In @ 7 O'Clock

Infiltration: **None** Pipe Seal Cond: **Unknown**

Drop Condition: **Open**
